# Lake Huron and Elgin Area Primary Water Supply Systems, Ontario, Canada

RISK-BASED ASSET MANAGEMENT APPROACH PREVENTS PCCP FAILURES AND SAVES UTILITY OVER CA\$1 MILLION

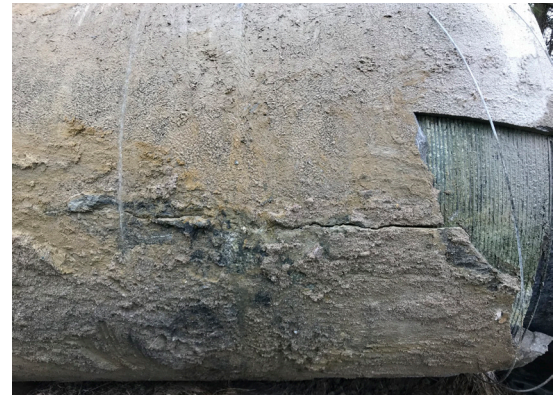
Since 2015, LHPWSS has replaced two distressed pipe sections in response to increasing wire break activity detected by the AFO platform. The most recent instance occurred in early 2020. The monitoring system alerted LHPWSS to an issue near the joint of two neighboring pipes. It was not clear whether the wire breaks were spread across both pipe sections, but a single pipe with that number of wire breaks could be dangerously close to its yield limit. The utility took a conservative approach and decided to proactively replace the pipe.

The SoundPrint AFO monitoring platform identified increasing wire break activity on this pipe in early 2020. LHPWSS' decision to replace the pipe prevented a potential catastrophic failure.

During replacement, Pure Technologies scanned the distressed pipes with an external electromagnetic tool to verify the monitoring results. The team confirmed that all wire breaks were on one pipe section. A large crack was visible on the pipe's underside as it was removed from the ground. The monitoring data and LHPWSS' decision had prevented a potential catastrophic failure.

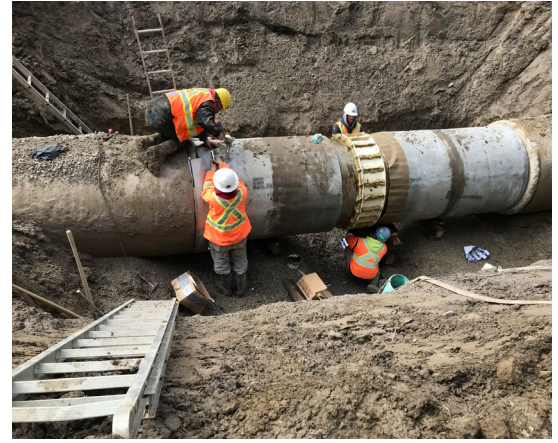
**Top:** With monitoring data, LHPWSS can conduct selective, proactive repairs rather than replace the entire pipeline.

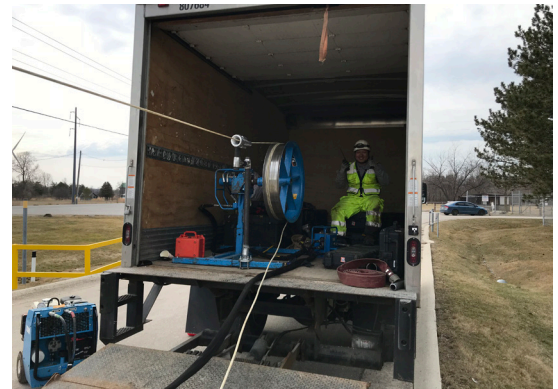
**Bottom:** Pure Technologies removes and reinstalls the fiber optic monitoring cable in a section of repaired pipe.
