# How to Detect Artifacts from Additional Sensors in Multibeam Data

By Ivan Isaak

Unlike a singlebeam echosounder, a multibeam system (MBES) requires more additional sensors to improve the quality of the data. Normally, in addition to the bathymetry, MBES data consists of data from an SV Profiler, a DGPS or RTK GPS, a Heading sensor (dual antenna GPS or a Gyro) and an attitude sensor (to measure heave, pitch and roll).

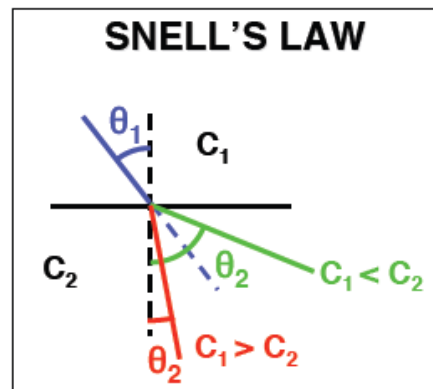
*FIGURE 1. Fig. 1 Sound Velocity refraction*

$$\frac{\sin \theta_1}{c_1} = \frac{\sin \theta_2}{c_2} = \text{ray parameter}$$

It is really important for the MBES to determine sound velocity profile in the water column to properly trace every individual beam. The farther the beam is from the nadir, the more effect of the sound velocity profile.

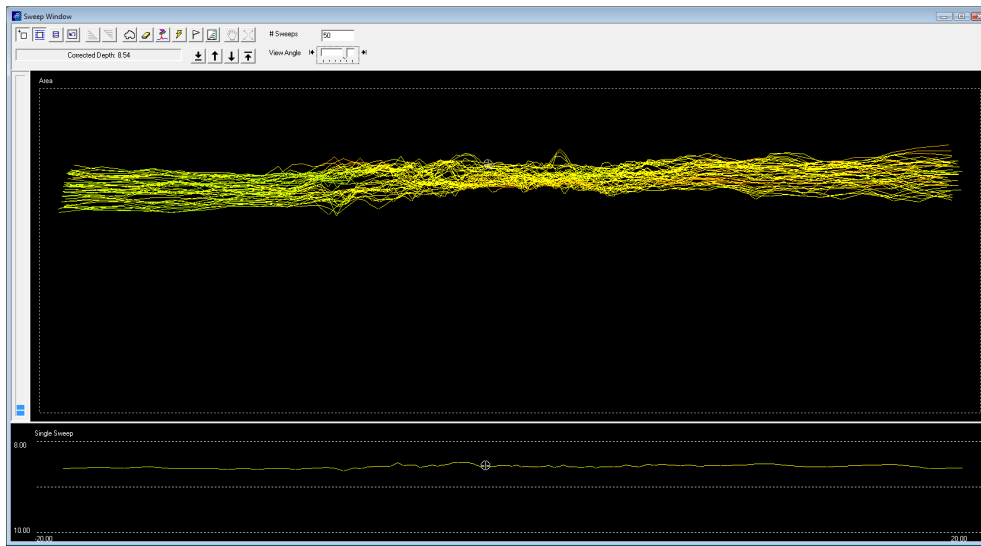
**FIGURE 2.** Good Sound Velocity – Flat Bottom.

As a result, an error in the ray tracing will lead to a banded bottom profile across the track. It is easy to detect such an artifact when looking at the cross section profile on a flat bottom. If there is a "smile" in the profile, it is evidence of the sound velocity artifacts in the data.

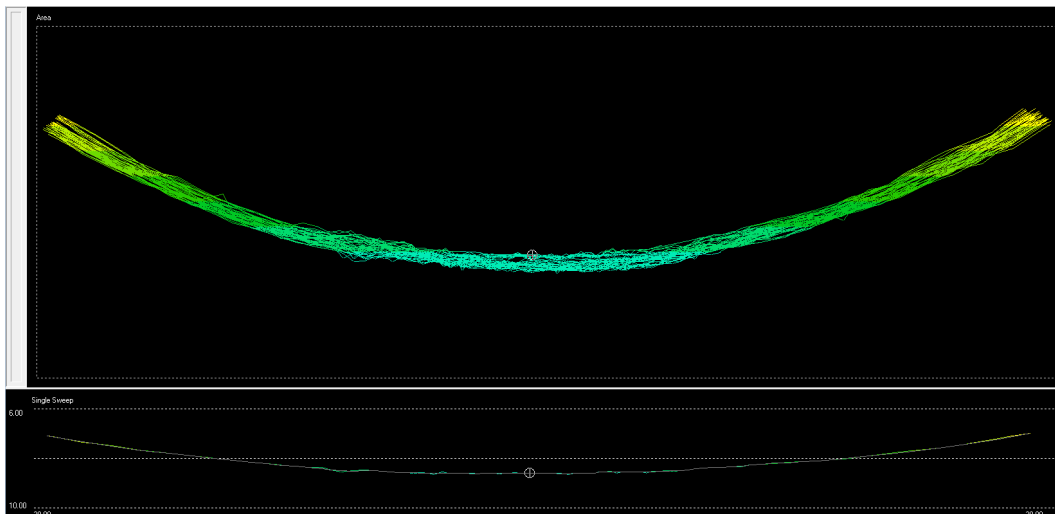
**FIGURE 3.** Abnormal Data Due to Sound Velocity Artifacts

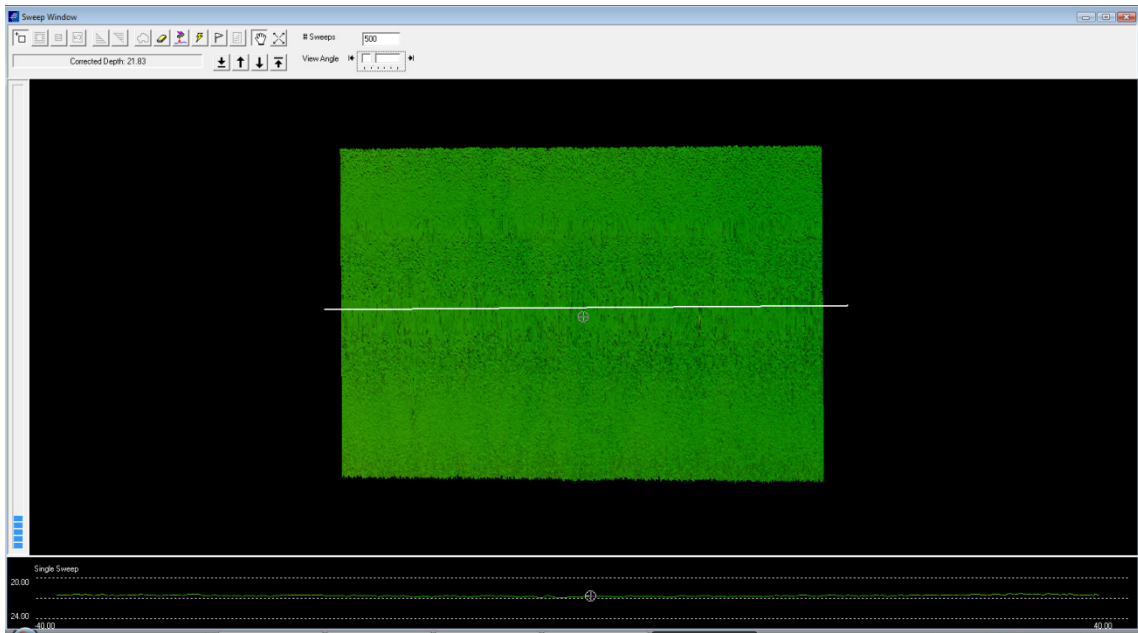
**FIGURE 4.** Along Track Data Corrected for Heave. The white line is a vessel track. Profile View of 500 sweeps in the HYSWEEP® EDITOR.

If there are no heave data or they are wrong, then the flat bottom will look wavy.

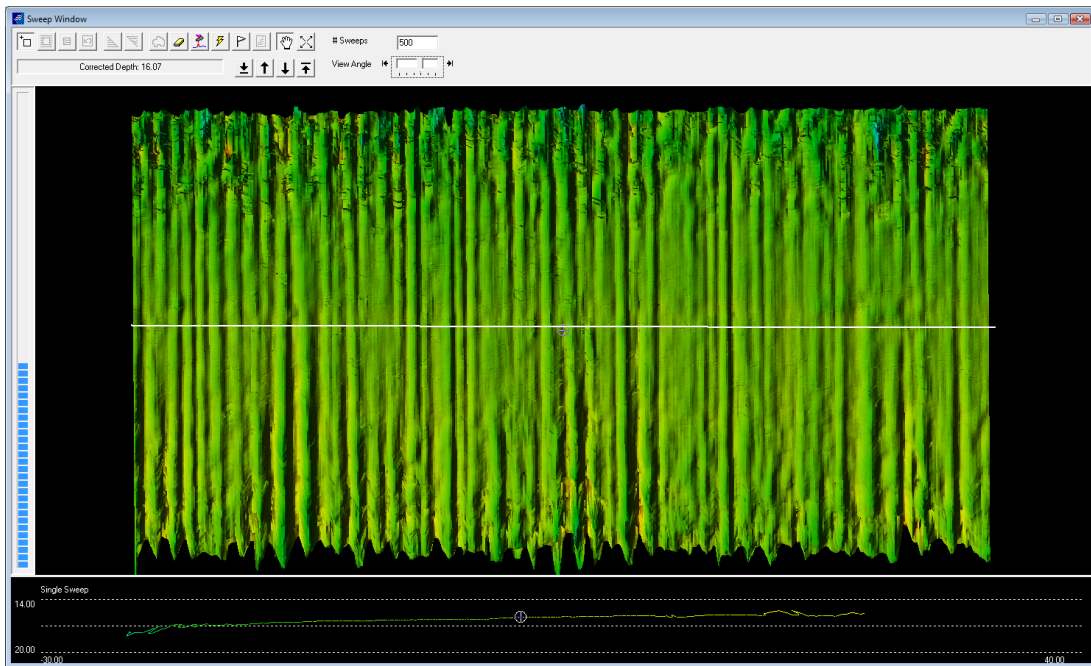
**FIGURE 5.** Along Track Data Not Corrected for Heave. Profile view of the 500 sweeps in the HYSWEEP® EDITOR, Phase 2 of Editing.

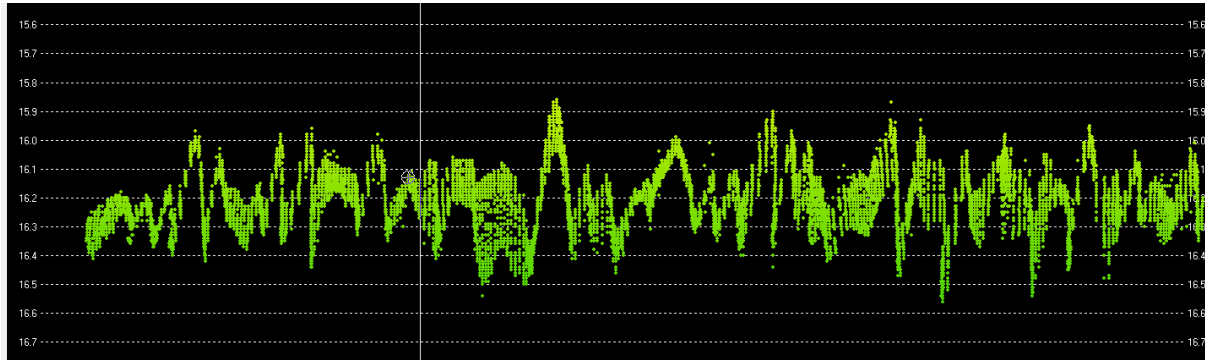
**FIGURE 6.** Along Track Profile with the Data Not Corrected for Heave. Profile View in Phase 3 of editing in the HYSWEEP® EDITOR

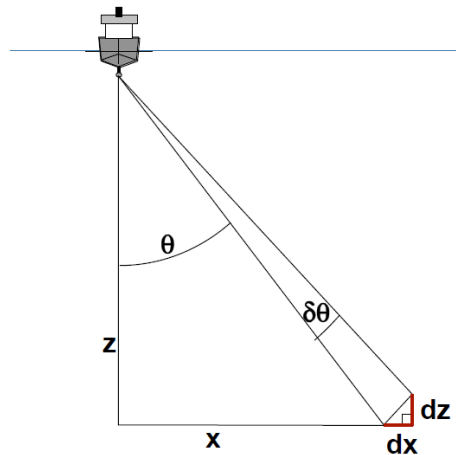
**FIGURE 7.** Roll effect

Roll affects the MBES data in both the horizontal and vertical planes, and more so on the outer beams.

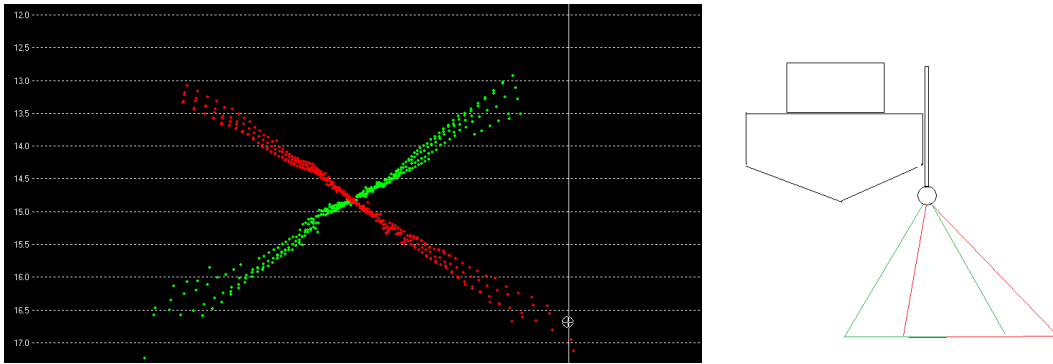
**FIGURE 8.** Cross Section Profile of the Two Data Sets in the Profile Window, Phase 3 of the HYSWEEP® EDITOR. No Roll Angle Correction.

Misalignment between the multibeam transducer and the MRU will lead to a big vertical error on outer beams.

To determine Roll angle one needs a flat area and two reciprocal lines. In Figure 8, Roll angle was  $2.9^\circ$ . The resulting cross sections after this angle was applied is shown in Figure 9. Another way to determine the roll angle is to measure alignment between sensors with the total station while the vessel is in the dry dock.

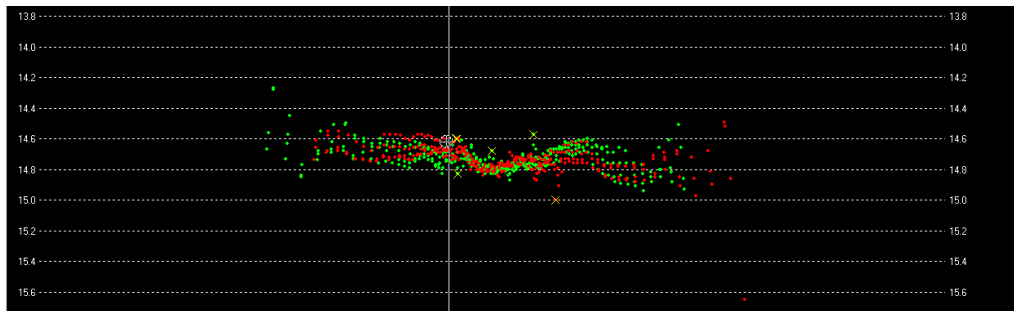
**FIGURE 9.** Fig. 9 Cross section profile of the two data sets in Profile Window, phase 3 of HYSWEEP® Editor. Roll angle correction was applied.

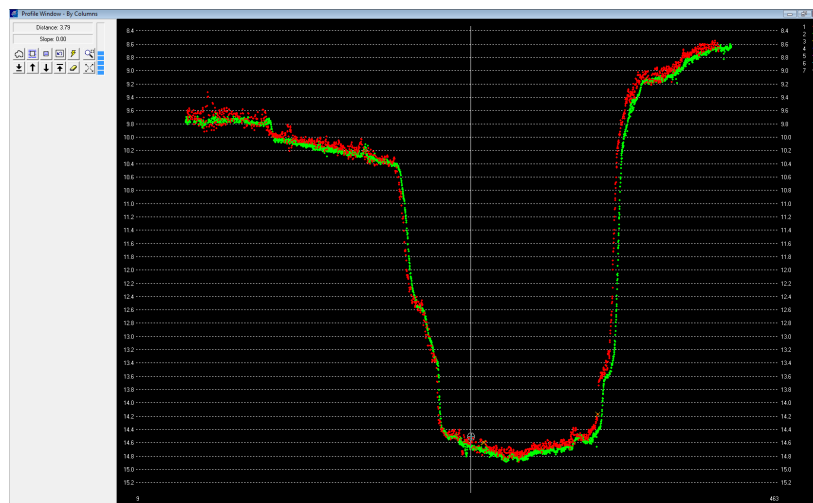
**FIGURE 11.** Profile View of two data sets with the latency artifact. HYSWEEP® Editor, Phase 3.

In Figure 11, a 1 sec. latency has led to a 3.4m shift of the slope at a 8-15m depth range.

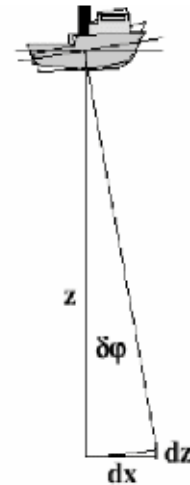
**FIGURE 12.** Pitch misalignment between MRU and MBE

Pitch misalignment between the MBE transducer and the MRU ( $\delta\phi$ ) can lead to horizontal and vertical error.

For example,  $5^\circ$  pitch angle errors can result in a depth error of 0.5% of the total water depth. But, since the ensonified area is generally aimed downward, the horizontal error is always greater and the significance of the pitch error is increased with depth.

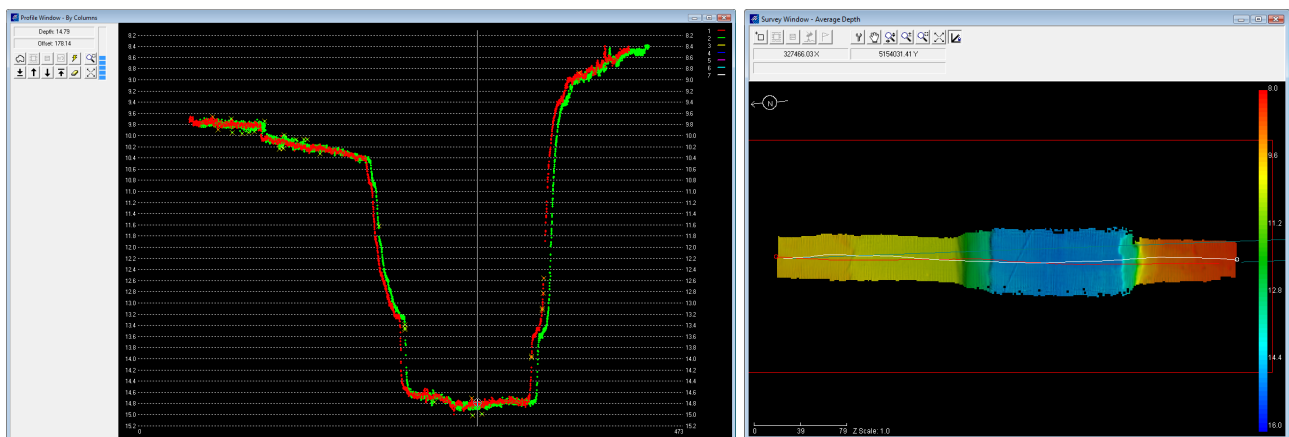
**FIGURE 13.** Pitch angle artifacts in the Profile window in Phase 3 of editing in the HYSWEEP® Editor.

In Figure 13, a pitch error of  $10^\circ$  has led to a 7.5m shift of the slope and a 0.05m vertical error at 15m depth.

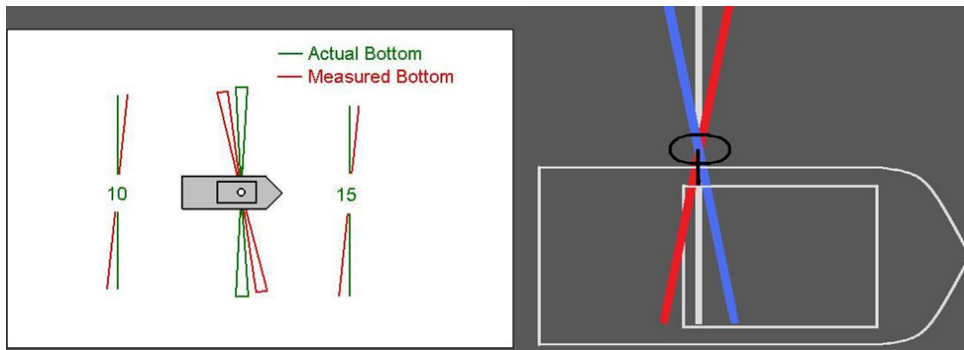
**FIGURE 14. Heading Misalignment**

Since the heading is defined in the horizontal plane, any error due to heading can only result in horizontal position error. This error increases with the beam angle and greater depths.

The highest portion of the heading error can appear due to angular misalignment between the MBE transducer and the vessel frame (or gyro heading).

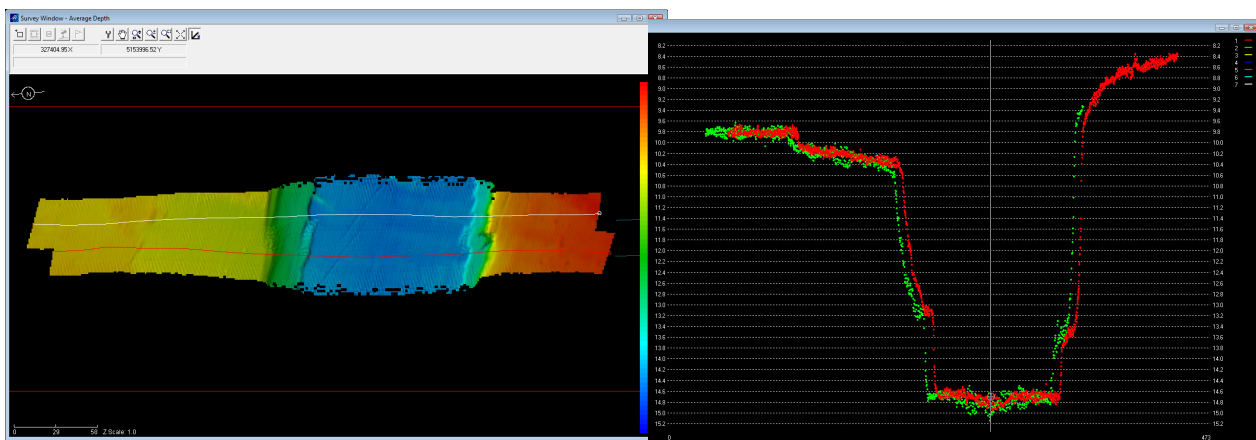
**FIGURE 15. Two Profiles in a Survey Window (left) and Profile Window (right) in Phase 3 in the HYSWEEP® EDITOR. Data are not corrected for Yaw.**

Heading misalignment can be detected visually by comparing two data sets, collected over two lines with one depth distance between them, run in the same direction over a prominent feature on the bottom. The deeper the area, the better. In the plan view, you can easily see the channel errors at two different passes and in the cross section view there is a prominent shift of the channel slopes.

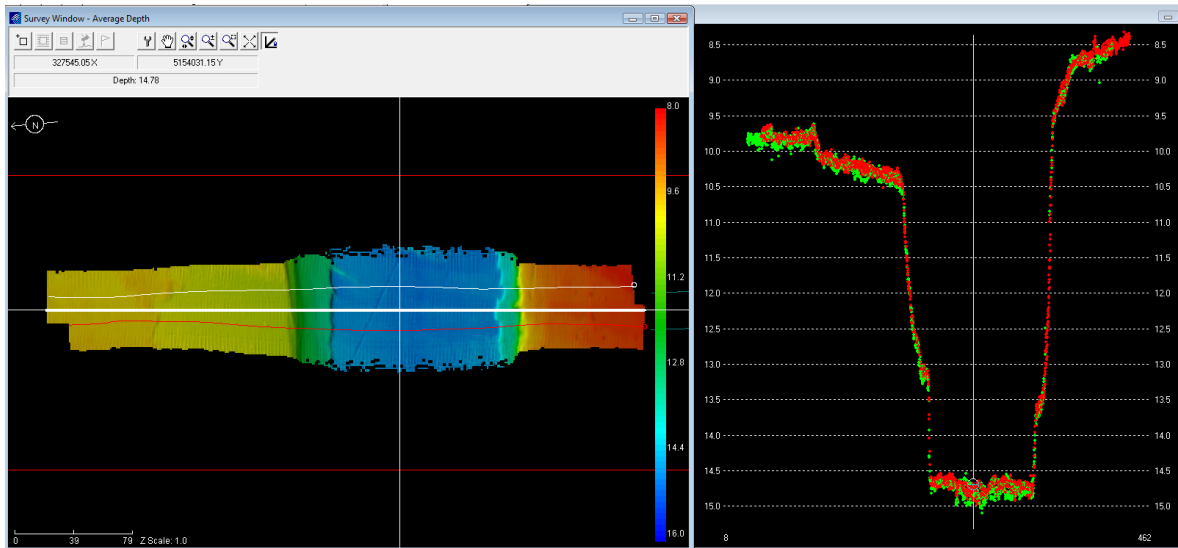
**FIGURE 16.** Data corrected for Yaw angle.
