## YSI Level Scouts® Monitor Groundwater Levels to Help Protect the Great Sphinx

Application Note

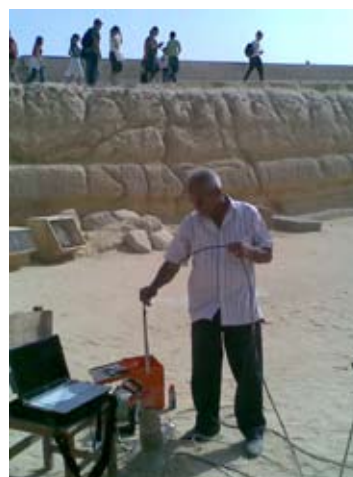
*A YSI Level Scout lowered into a well.*

After the camera work was completed, YSI Level Scout® pressure transducers were deployed in 4 monitoring stations at a depth of 15 meters (49 feet) from the ground surface to provide secure, long-term unattended monitoring of the water table, notes Mohamed Adel, Senior Engineer of Cairo University Engineering Center. Rugged, reliable and equipped with absolute gauge, each Level Scout records level data every eight hours, and is capable of recording up to 400,000 data points in its internal memory. The instruments can also be equipped to broadcast data via SDI-12, RS232 or RS485 for real-time data acquisition. Software included with Level Scouts facilitates data management on PCs or Pocket PCs.

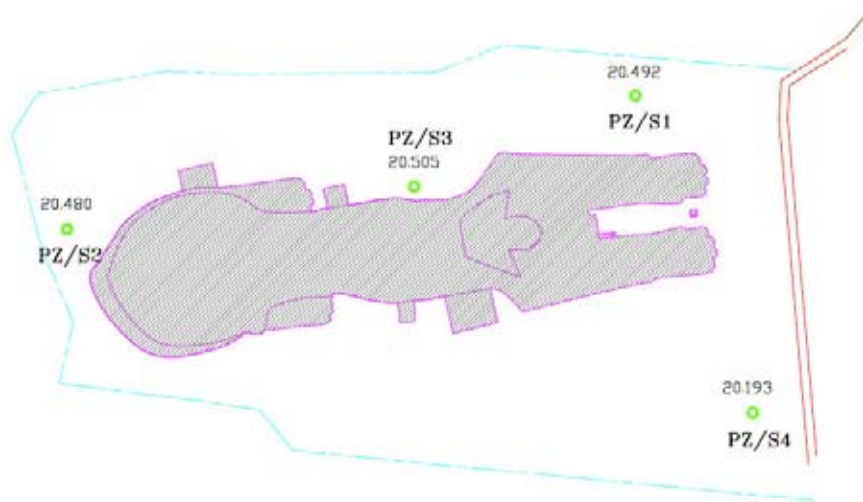
*Diagram showing the location of the four boreholes at the base of the Sphinx (Council of Antiquities, Project Sector and Cairo Engineering Center for Archaeology and Environment).*

Researchers drilled four boreholes four-inches in diameter and 20 meters (66 feet) deep into the bedrock beneath the Sphinx. They dropped cameras into the four-inch boreholes to look into the rocks supporting the statue.
