Emergency Bypass for Sewer Facility Circumvents Natural and Manmade Obstacles

Xylem team responds quickly with a comprehensive bypass solution that maintains facility infrastructure and environmental stewardship

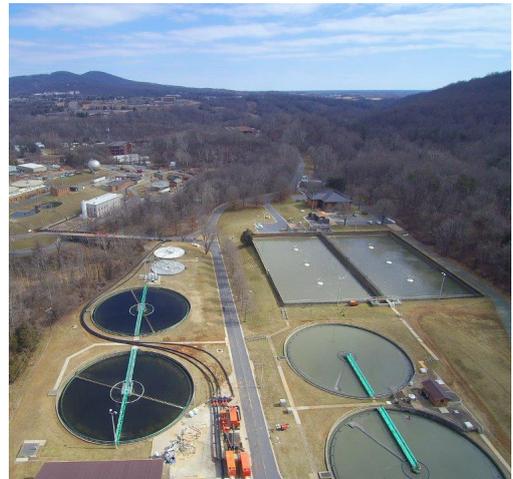
The emergency bypass to facilitate the repair of the 54-inch secondary effluent water pipe required some twists and turns in the 18-inch HDPE rental pipe.

The Xylem team immediately began mobilizing pipe and the necessary rental equipment for the temporary bypass. To handle the 30 million gallons per day (MGD) of flow that RWSA needed, the bypass would require three flanking lines of 18-inch high-density polyethylene (HDPE) pipe.

The length of the bypass turned out to be approximately 1,400 feet for each 18-inch line, and 5,000 feet of pipe was mobilized

quickly from several Xylem rental locations. Once on location at Moores Creek, the pipe was fused and assembled by Xylem technicians, 500 feet at a time and then dragged into place and fused together.

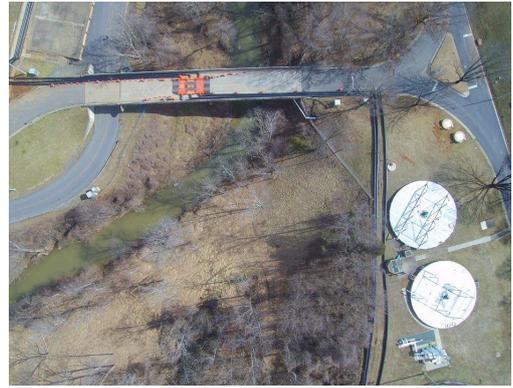
Keeping the busy access bridge open was a priority during the month-long bypass.

Since the bypass had to negotiate the busy bridge without shutting down traffic, the Xylem team worked 24/7 shifts to expedite the installation, completing the installation in less than a week. Once the flank of pipes was in place across the bridge and across the line of traffic, three road ramps were provided to maintain bridge access during the month-long emergency bypass operation. Ultimately, the quick response by the Rivanna team, supported by Xylem team efforts and systems, was an example of the true environmental stewardship that RWSA is known for - with a vital focus on keeping their local streams and rivers safe from negative environmental impact.

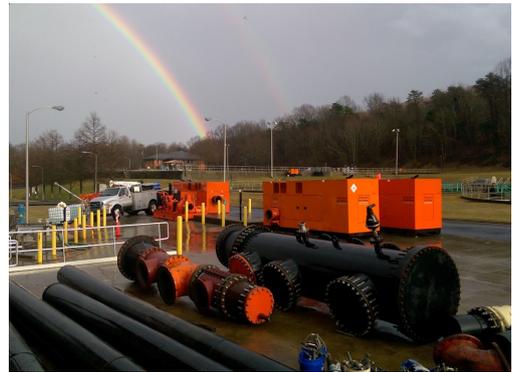
The Xylem team setting up pumps.

To power the bypass, four Godwin diesel-driven, critically silenced CD400M Dri-Prime pumps were mobilized and installed. To save energy and diesel fuel costs, the pumps were installed and started sequentially, only coming online as needed.

Each of the three 18-inch lines had a dedicated pump capable of handling approximately 10 MGD of flow, and each pump was set up with a level transducer, which was pre-set to turn the diesel pumps on/off depending on fluid level in the wet well. If the system flow in a line increased, its pump was automatically activated. During lower flow, one or possibly two pumps would be running, but as many as three pumps would run during higher, peak-flow activity.

The fourth pump was an open-canopy redundant mechanical back-up that would kick-in if any of the other three pumps failed. For additional peace of mind, the bypass system included an alarm agent that was programmed to alert RWSA personnel if the pump wasn't running at optimal levels, or was possibly approaching pump failure.
