# N-Pumps solve clogging problems at Vancouver Island's Victoria Hospital

and improve health & safety conditions for the maintenance employees

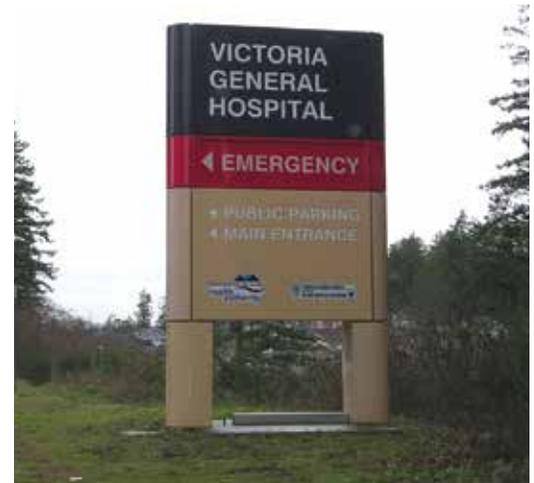
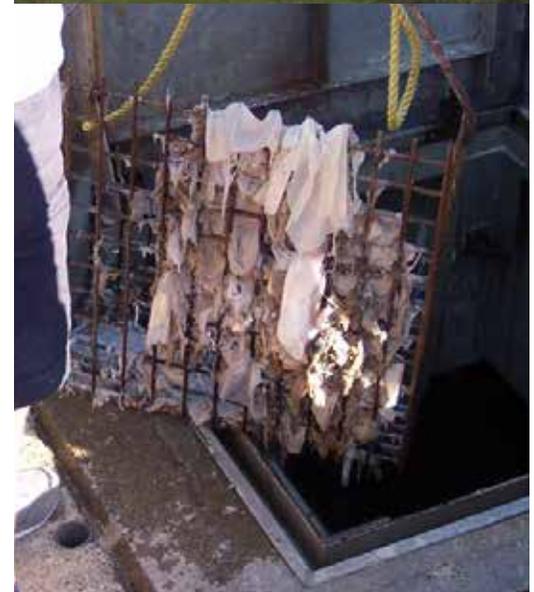
One of the screens collecting solid materials from getting into the wet well.

Another solution that was put in place was to build a couple of screens that were installed before the inlet of the station. The screen collects and prevents the solid materials from getting into the wet well thereby preventing the pumps from clogging. With the screen in place, the hospital's maintenance crew is tasked with the job of cleaning the screen twice a day, once in the morning and once in the late afternoon. The materials normally removed by the baskets as experienced by the maintenance crew are:
